# STREAM INVENTORY REPORT

## Cheney Gulch

A stream inventory was conducted during 10/24/2006 to 10/27/2006 on Cheney Gulch. The survey began at the confluence with Bodega Harbor and extended upstream approximately 3 miles. The objective of the habitat inventory was to document the habitat available to anadromous salmonids in Cheney Gulch.

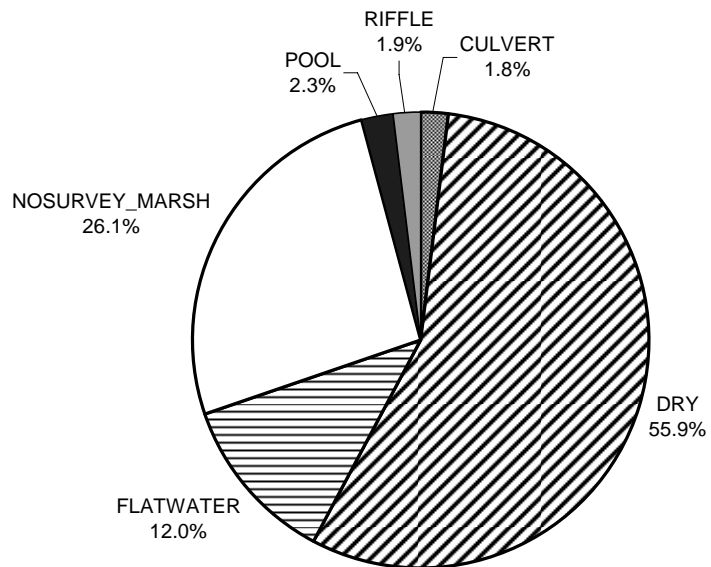
GRAPH 2

Table 1 summarizes the Level II riffle, flatwater, and pool habitat types. Based on frequency of occurrence there were 3.6% not surveyed due to marsh units, 10.9% culvert units, 18.2% pool units, 25.5% dry units, 29.1% flatwater units and 12.7% riffle units (Graph 1). Based on total length of Level II habitat types there were 26.1% nosurvey marsh units, 1.8% culvert units, 2.3% pool units, 55.9% dry units, 12.0% flatwater units and 1.9% riffle units (Graph 2).

**CHENEY GULCH 2006  
HABITAT TYPES BY PERCENT TOTAL LENGTH**

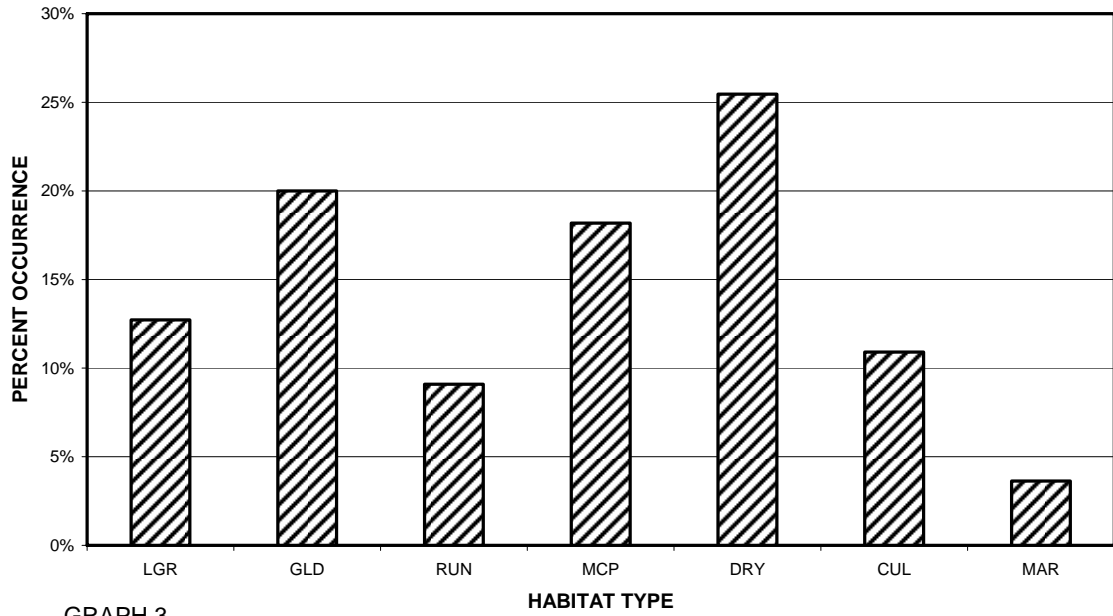
GRAPH 3

Five Level IV habitat types were identified (Table 2). The most frequent habitat types by percent occurrence were 18% Mid-Channel Pool units, 25% Dry units, and 20% Glide units (Graph 3). Based on percent total length, the most frequent habitat types were found to be 26% Not Surveyed due to marsh units, 56% Dry units, and 11% Glide units.

**CHENEY GULCH 2006  
HABITAT TYPES BY PERCENT OCCURRENCE**

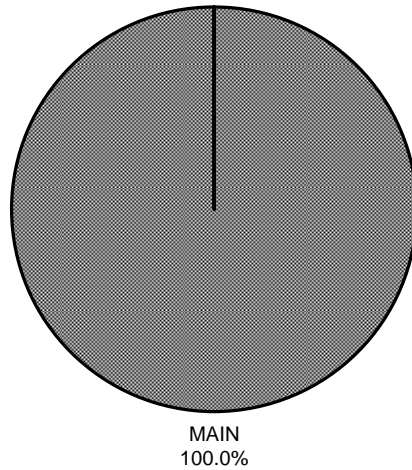
GRAPH 4

A total of 10 pools were identified (Table 3). Main Channel pools were encountered at 100%, and comprised 100% of the total length of all pools (Graph 4).

**CHENEY GULCH 2006  
POOL TYPES BY PERCENT OCCURRENCE**

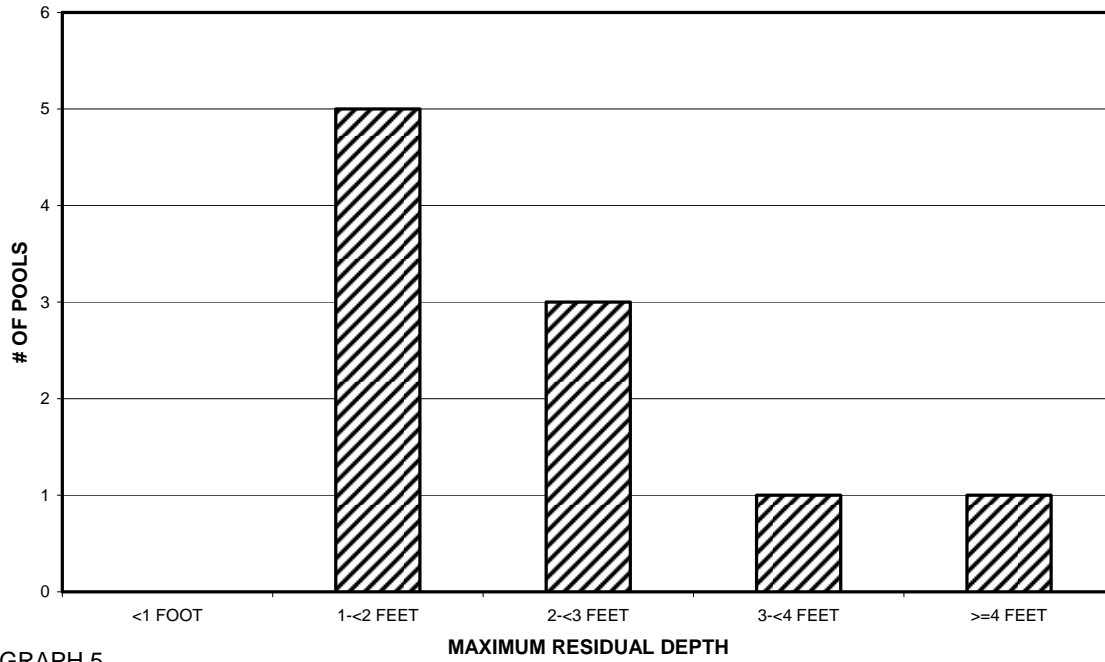
GRAPH 5

Table 4 is a summary of maximum residual pool depths by pool habitat types. Pool quality for salmonids increases with depth. Five of the 10 pools (50%) had a residual depth of two feet or greater (Graph 5).

## CHENEY GULCH 2006 MAXIMUM DEPTH IN POOLS

- 3) Where feasible, design and engineer pool enhancement structures to increase the number of pools. This must be done where the banks are stable or in conjunction with stream bank armor to prevent erosion.

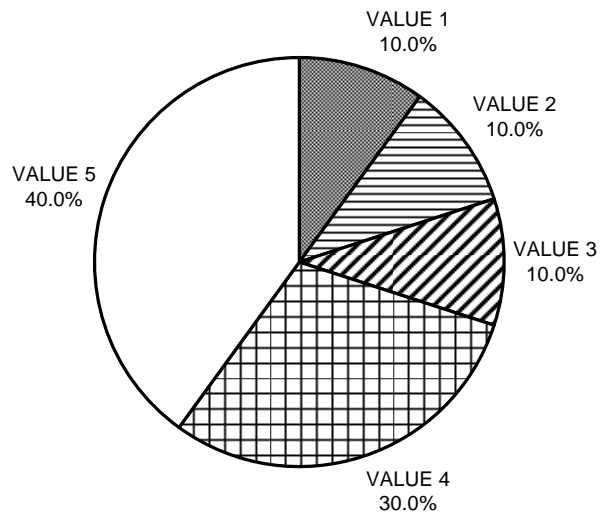
GRAPH 6

The depth of cobble embeddedness was estimated at pool tail-outs. Of the 10 pool tail-outs measured, 1 had a value of 1 (10%); 1 had a value of 2 (10%); 1 had a value of 3 (10%); 3 had a value of 4 (30%); 4 had a value of 5 (40%) (Graph 6). On this scale, a value of 1 indicates the best spawning conditions and a value of 4 the worst. Additionally, a value of 5 was assigned to tail-outs deemed unsuited for spawning due to inappropriate substrate such as bedrock, log sills, boulders, or other considerations.

Two of the 10 pool tail-outs measured had embeddedness ratings of 1 or 2. Four of the pool tail-outs had embeddedness ratings of 3 or 4. Four of the pool tail-outs had a rating of 5, which is considered unsuitable for spawning. Cobble embeddedness measured to be 25% or less, a rating of 1, is considered to indicate good quality spawning substrate for salmon and steelhead. Sediment sources in Cheney Gulch should be mapped and rated according to their potential sediment yields, and control measures should be taken.

## CHENEY GULCH 2006 PERCENT EMBEDDEDNESS

- 6) Inventory and map sources of stream bank erosion and prioritize them according to present and potential sediment yield. Identified sites should then be treated to reduce the amount of fine sediments entering the stream.

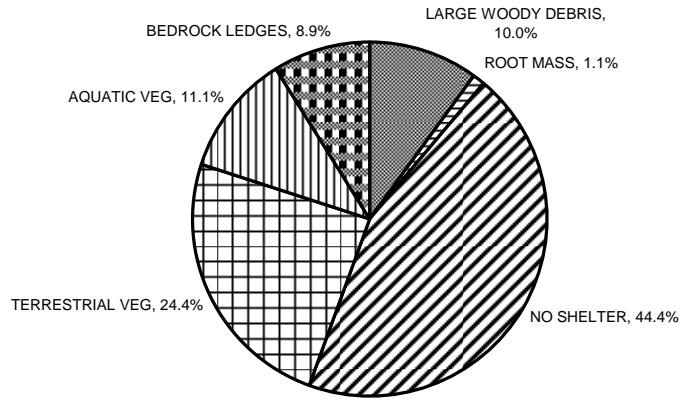
GRAPH 7

Table 5 summarizes mean percent cover by habitat type. Terrestrial Vegetation is the dominant cover type in Cheney Gulch. Graph 7 describes the pool cover in Cheney Gulch. Terrestrial Vegetation is the dominant pool cover type followed by aquatic vegetation.

The mean shelter rating for pools was 18 and for flatwater habitats it was 12. A pool shelter rating of approximately 100 is desirable. The amount of cover that now exists is being provided primarily by Terrestrial Vegetation in Cheney Gulch. Terrestrial Vegetation is the dominant cover type in pools followed by aquatic vegetation. Log and root wad cover structures in the pool and flatwater habitats would enhance both summer and winter salmonid habitat. Log cover structure provides rearing fry with protection from predation, rest from water velocity, and also divides territorial units to reduce density related competition.

## CHENEY GULCH 2006 MEAN PERCENT COVER TYPES IN POOLS

- 4) Increase woody cover in the pools and flatwater habitat units. Most of the existing cover in the pools is from Terrestrial Vegetation. Adding high quality complexity with woody cover in the pools is desirable.

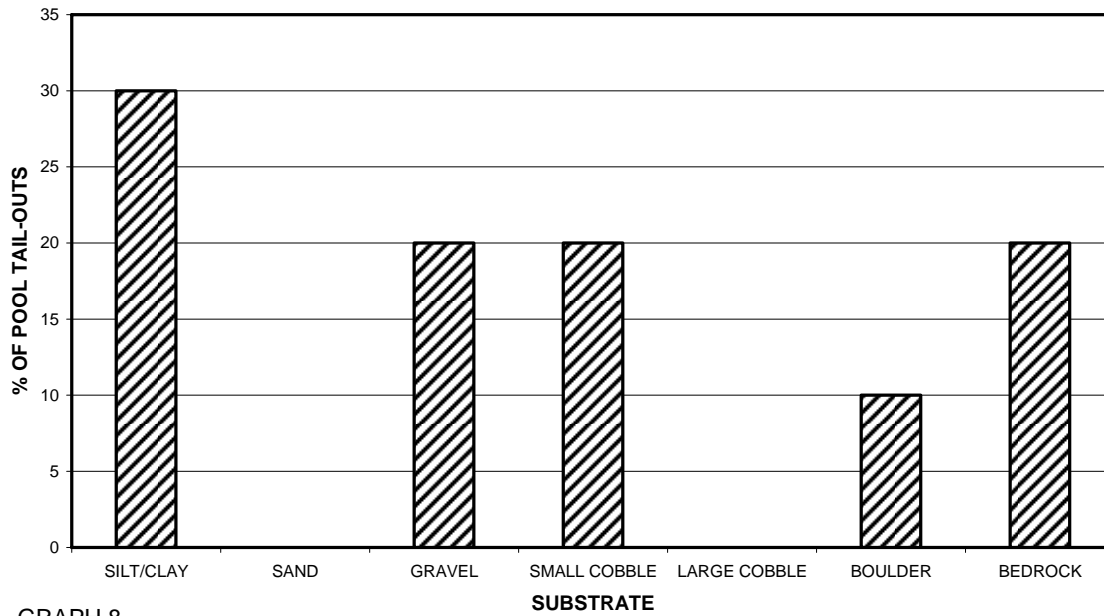
GRAPH 8

Table 6 summarizes the dominant substrate by habitat type. Graph 8 depicts the dominant substrate observed in pool tail-outs. A silt/clay substrate type was observed in 30% of pool tail-outs, gravel observed in 20% of pool tail-outs, small cobble observed in 20% of pool tail-outs, and bedrock observed in 20% of pool tail-outs.

Six of the 10 pool tail-outs had silt, sand, large cobble, boulders or bedrock as the dominant substrate. This is generally considered unsuitable for spawning salmonids.

## CHENEY GULCH 2006 SUBSTRATE COMPOSITION IN POOL TAIL-OUTS

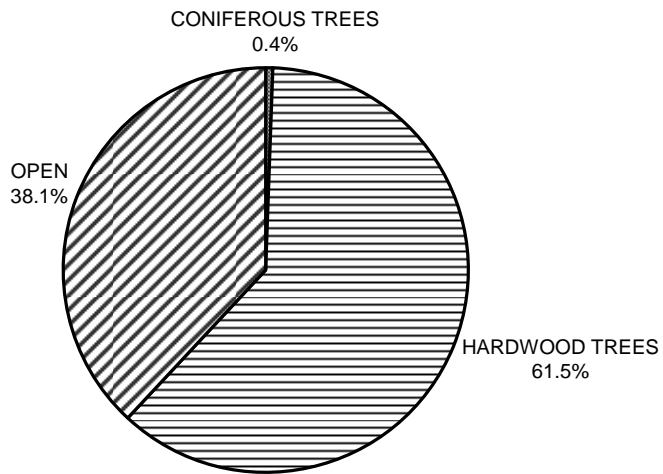
GRAPH 9

The mean percent canopy density for the surveyed length of Cheney Gulch was 62%. The mean percentages of hardwood and coniferous trees were 99% and 1%, respectively. Thirty-eight percent of the canopy was open (Table 7). Graph 9 describes the mean percent canopy in Cheney Gulch.

The mean percent canopy density for the stream was 62%. Reach 1 had a canopy density of 75%, Reach 2 had a canopy density of 91%, Reach 3 had a canopy density of 69%, and reach 4 had a canopy density of 33%. In general, revegetation projects are considered when canopy density is less than 80%.

**CHENEY GULCH 2006  
MEAN PERCENT CANOPY**

- 8) Increase the canopy in Reaches 3 and 4 on Cheney Gulch by planting appropriate native vegetation like willow, alder, redwood, and Douglas fir along the stream where shade canopy is not at acceptable levels. The reaches above this survey section should be inventoried and treated as well, since the water flowing here is affected from upstream. In many cases, planting will need to be coordinated to follow bank stabilization or upslope erosion control projects.

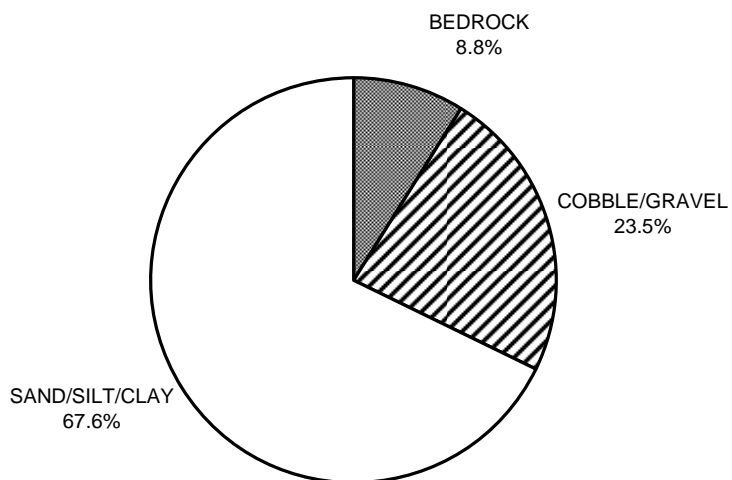
GRAPH 10

For the stream reach surveyed, the mean percent right bank vegetated was 76% and the mean percent left bank vegetated was 68% (Table 7). The dominant elements composing the structure of the stream banks consisted of 9% bedrock, 24% cobble/gravel and 68% sand/silt/clay (Graph 10). Both Hardwood trees and Grass were dominant vegetation types each observed in 38% of the units surveyed. Additionally, 24% of the units surveyed had Brush as the dominant vegetation type. (Graph 11).

**CHENEY GULCH 2006  
DOMINANT BANK COMPOSITION IN SURVEY REACH**

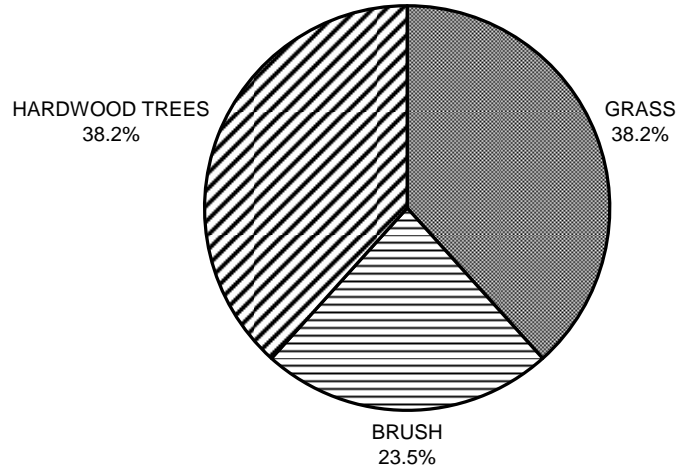
GRAPH 11

**CHENEY GULCH 2006  
DOMINANT BANK VEGETATION IN SURVEY REACH**

The percentage of right and left bank covered with vegetation was 76% and 68%, respectively. In areas of stream bank erosion or where bank vegetation is sparse, planting endemic species of coniferous and hardwood trees, in conjunction with bank stabilization, is recommended.
