Community Clean Water Institute

Dutch Bill Creek Fact Sheet

Recent Creek Monitoring Project

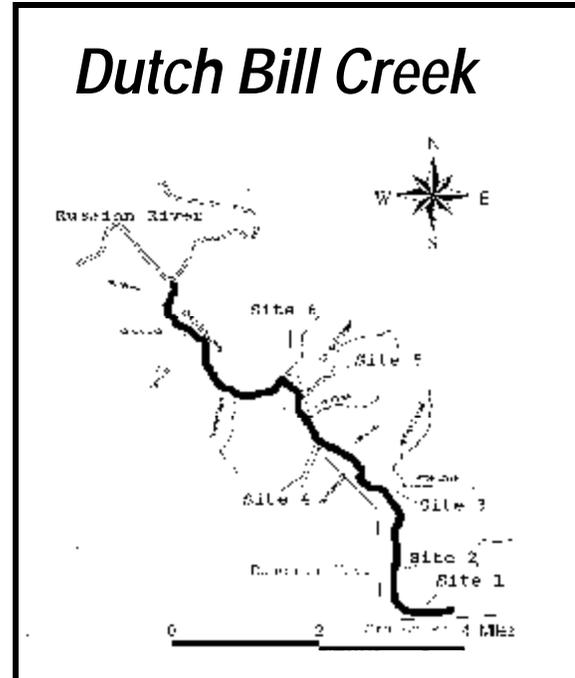
Sites

Starting from Occidental, going towards Monte Rio

Site 1: At bridge near Graton Rd. and Main Street near Harmony School

Site 2: 75 yards downstream from pump station, after narrow flow

Site 3: Lancel Creek- near railroad trestle

Site 4: Camp Meeker Dam

Site 5: Downstream from Bohemia Ranch, where Grub Creek enters Dutch Bill Creek on Westminster Woods property

Site 6: Fish ladder

CCWI sampled at 6 sites along Dutch Bill Creek on March 26th, 2002. Sites were chosen for representative creek characterization, potential for effects from wastewater discharges, erosion from dirt roads, or other potential sources, and accessibility and use in future citizen monitoring projects.

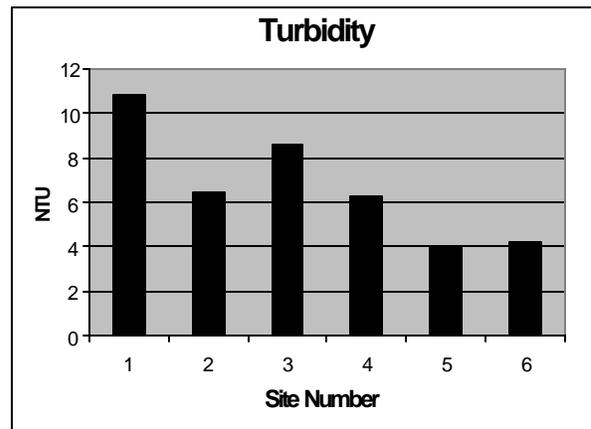
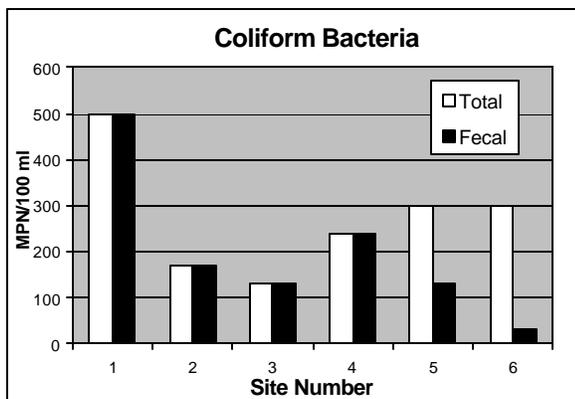
Turbidity: Turbidity is a measure of the amount of suspended particles such as algae, sediment, or organic matter. Turbidity was highest upstream at Site 1, with a reading of 10.8 NTU. At this level of turbidity, fish navigation is not impaired, but the creek does not meet drinking water standards.

Coliform: Coliform is a type of bacteria found in creeks. Coliform is a measure of the sanitary conditions in a waterway. Fecal coliform are those found in the feces of warm blooded animals. Coliform numbers were greatest at the top of the creek. Preventing cattle from grazing in the creek is one way to reduce fecal coliform counts.

Site 1 was the most impacted of 6 sites monitored, for both turbidity and coliform. Sites and tributaries downstream registered cleaner, suggesting that the source of pollution is upstream from Site 1, between Harmony School and the Waste Treatment discharge point. Sources of bacteria above Site 1 could be the Occidental Wastewater Treatment Plant, cattle grazing near the headwaters of the creek, or similar activities near the creek. The Best Practices on the facing page show ways residents can help protect the water quality of Dutch Bill Creek. Future monitoring at sites 1 and 6 at a higher sampling frequency would be effective in assessing the water quality over time. Such a monitoring program will establish a benchmark for this waterway. Contact CCWI to become involved in the Dutch Bill Creek Citizen Monitoring Program.
